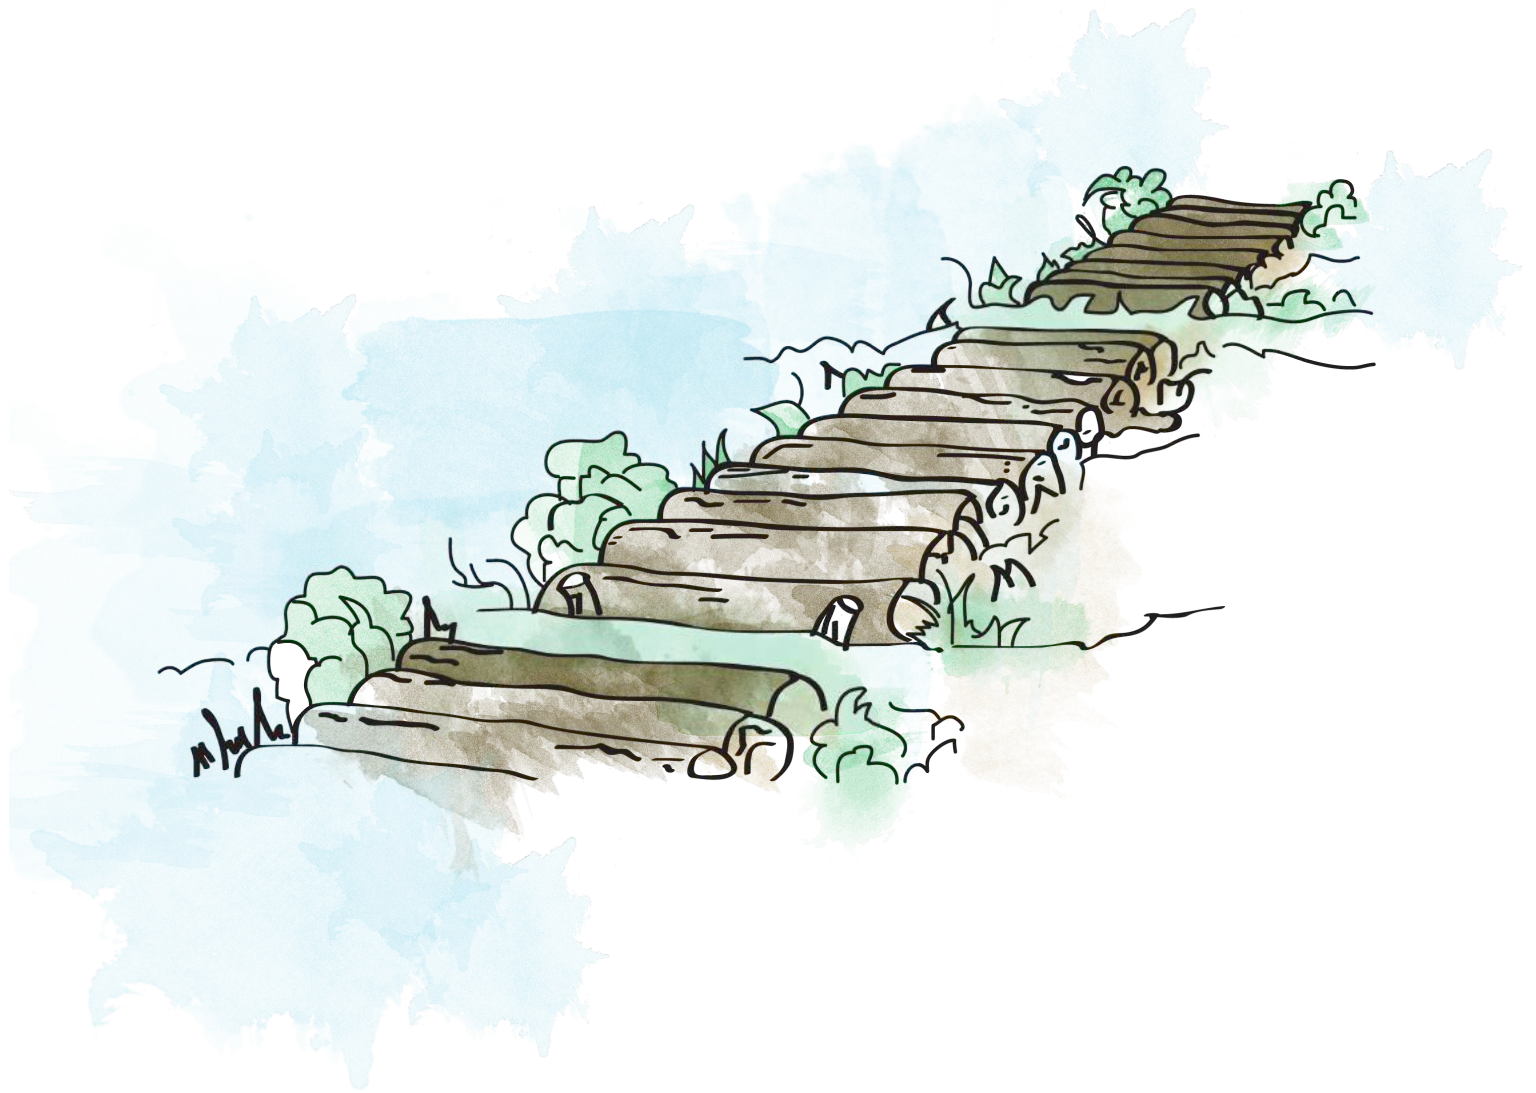
Figure 7: Corduroy Trail Showing Space for Drainage Channels
